## INFORMATION REPORT

COUNTRY	Poland	REPORT	
SUBJECT	Observations at Swinoujscie Harbor	DATE DISTR.	12 June 1953
		NO. OF PAGES	3
DATE OF INFO.		REQUIREMENT NO.	RD
PLACE ACQUIRED		REFERENCES	25X1

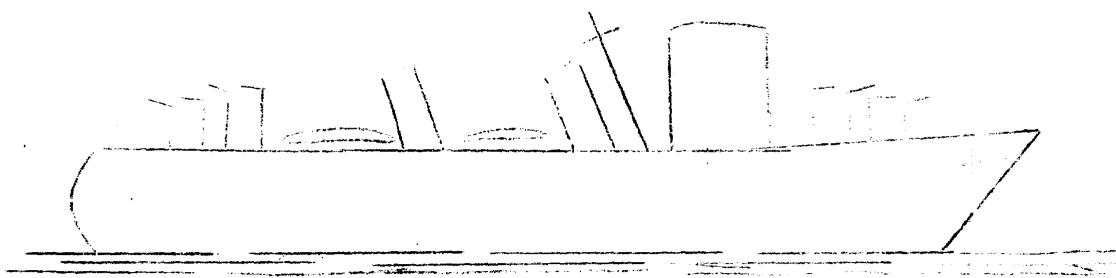
were about 80 to 100 meters in length, and they had two smokestacks. A mast with a radar antenna was located between the bridge and the foremast, and each ship had six torpedo ejectors and four guns in armored housings. The guns, two of which were on the forecastle and two on the stern, appeared to have a caliber of over 100 mm. (A sketch of one of the destroyers is attached.)

Sketch of Soviet destroyer  observed at Swinoujscie
